**Elliott, LeBoeuf & McElwain**

## **Dominion Hills Area Recreation Association Structural Evaluation of Existing Swimming Pools**

**23 June 2022**

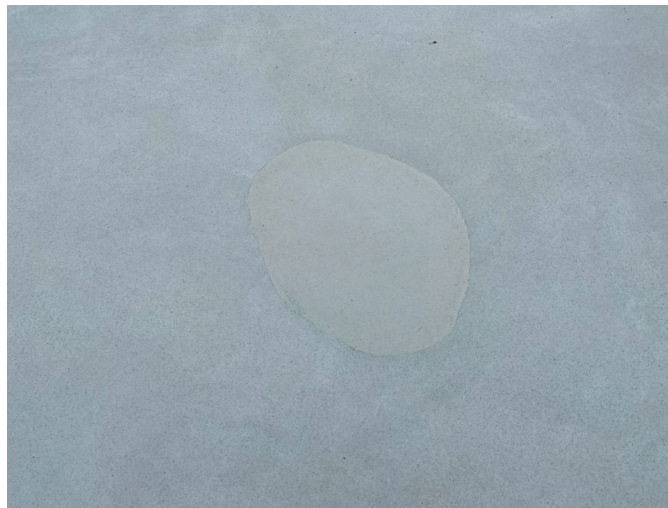
There were numerous locations throughout the pool floor and a few locations on the walls where the pool shell sounded hollow. Most of these areas were relatively small, on the order of 1 to 2 square feet, while others were larger. In a number of locations, the hollow sounding area was adjacent to an area where the white coat was previously patched.

Main Pool – Previously Patched White Coat

It is most likely that the hollow sound is a delaminated area, where a portion of the pool plaster has separated from the surrounding plaster, with the underlying structure undamaged. A less likely possibility is that the hollow sound indicates deterioration of the underlying pool shell. If this were the case, we would expect the damage to be more extensive than what was observed.

Remove the pool plaster in the hollow sounding areas deep enough to remove all of the delaminated plaster and provide a multi-layer repair with a scratch coat and finish coat(s). As part of the removal process, it will be determined if the delamination extends all the way to the concrete shell (potentially requiring concrete repair), or if the damage is limited to the pool plaster, as expected.

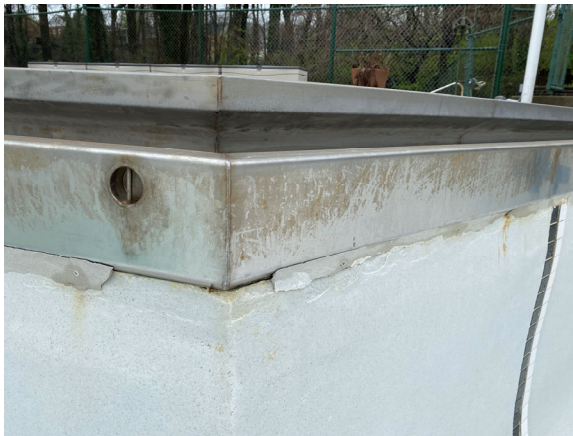
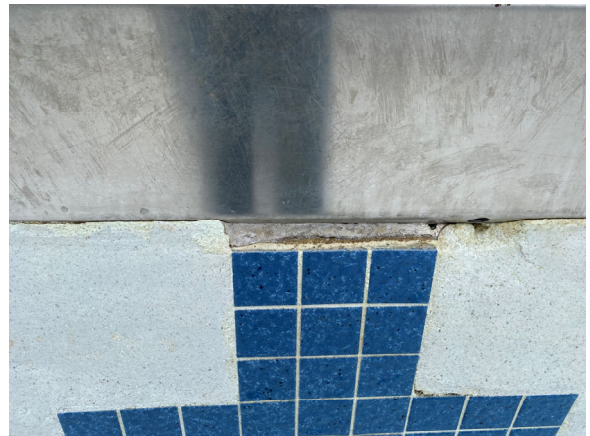
A typical condition is that the pool plaster at the top of the wall beneath the stainless steel gutter is separated from the gutter and, in many cases, damaged and loosened.

Main Pool – Loose Plaster Beneath Stainless Steel Gutter

The interface between the pool wall and the stainless steel gutter is a vulnerable condition subject to differential thermal movements (cyclical temperature related expansion and contraction). Brittle plaster layered over sealant in a moving condition is not a suitable detail for this condition.

The interface between the pool wall and the gutter must be properly sealed to prevent pool water from entering the joint and leading to corrosion of the pool shell structure. A repair detail will need to be developed that can accommodate the complex movements at this interface. Refer also to Item 4.1.5 below.

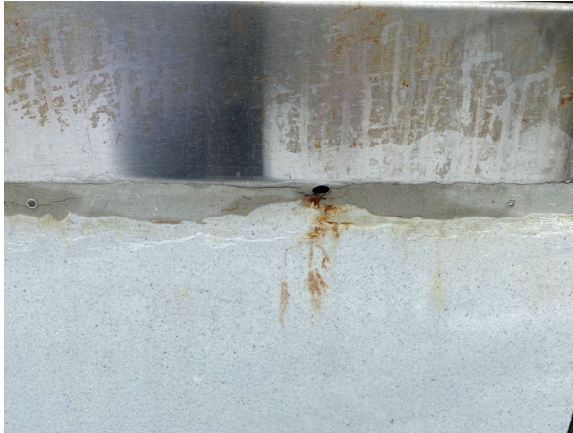
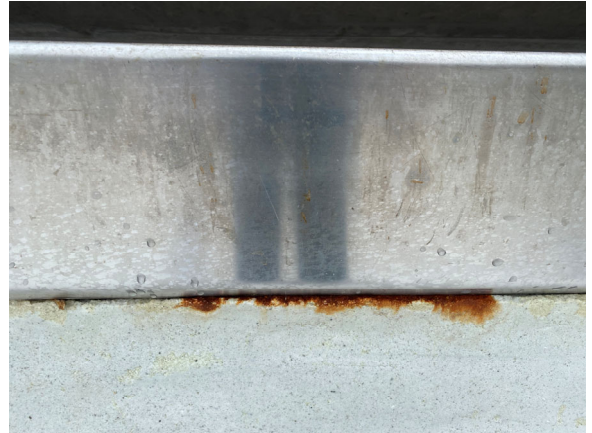
There is rust staining on the pool plaster beneath the stainless steel gutter. Frequently this occurs at weep holes in the gutter as well as in some other isolated locations.

Main Pool – Rust Staining Below Stainless Steel Gutter

The staining is the result of corrosion. It is likely that there are hidden fasteners or anchors that are either carbon steel or a stainless steel alloy that is less resistant to corrosion than the stainless steel alloy used to fabricate the gutter.

Ideally, any carbon steel or less corrosion-resistant components should be removed and replaced with highly corrosion-resistant stainless steel. However, in practice, it may be very difficult to find and remove these components without a significant demolition effort that would likely involve removing large sections of the gutter. At a minimum, any corroding fasteners or anchors exposed as part of the repair of Item 4.1.2 above should be replaced.

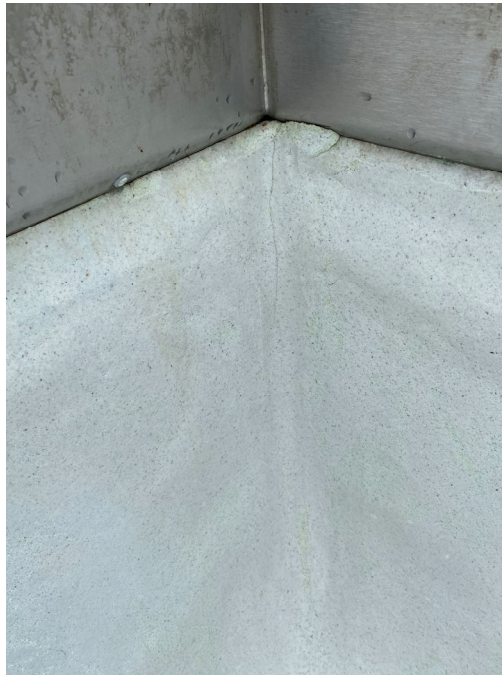
There is hairline vertical crack at the southwest corner of the Training Area on the east side of the bulkhead that subdivides the Main Pool.

Main Pool – Wall Crack at Southwest Corner of Training Area

The crack is the result of thermal movement (cyclical temperature related expansion and contraction). It is likely the result of expansion and contraction of the intersecting gutter sections and/or thermal expansion and contraction of the gutter itself.

Remove the pool plaster in the corner and provide a multi-layer repair with a scratch coat and finish coat(s).

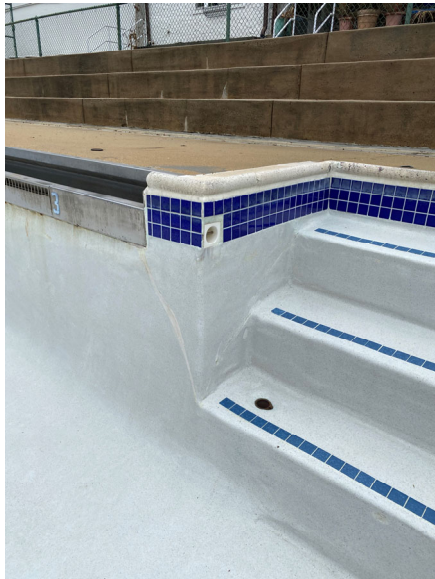
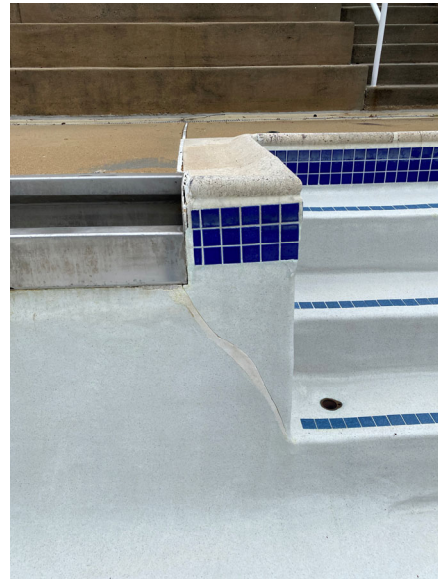
At the stair on the north side of the Main Pool, adjacent to the bulkhead, there is cracking of the wall on the west side of the stair.

Main Pool – Cracking of Wall on West Side of North Stair

The wall cracking, coping separation from the pool deck, and failed sealant are the result of thermal movements of the stainless steel gutter. The gutter on the west side of the damaged wall at the stair undergoes a change in length of approximately 0.6" for an 80 degree temperature swing. The gutter is 0.6" longer on the typical hottest summer day versus the coldest winter day.

1. Cut the gutter back at the stair to allow for thermal expansion without exerting pressure on the wall.
2. Seal with the gap between the gutter and the stair. Note that this will become a maintenance item.
3. Repair the wall. It is likely that the concrete wall has been damaged. The plaster should be removed down to the concrete so that the wall can be assessed and repaired if warranted by any damage that is uncovered.

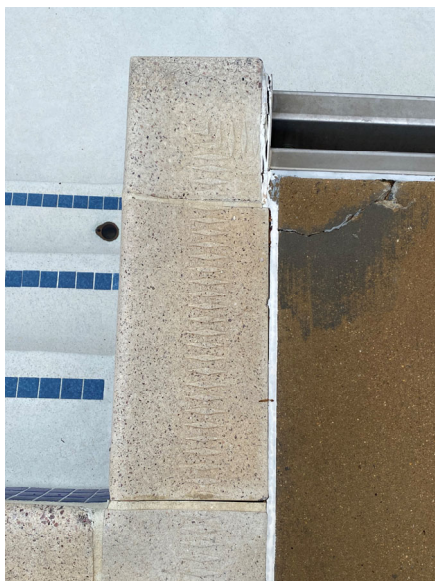
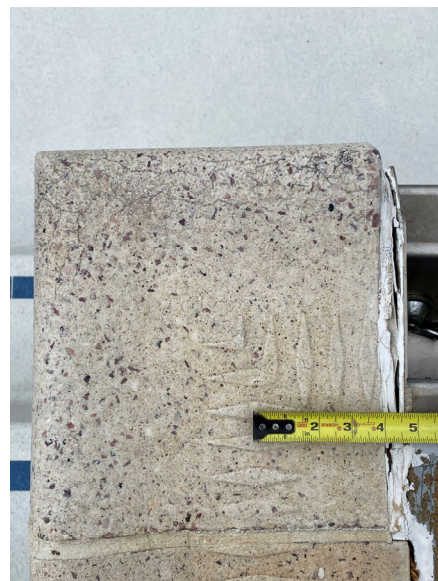
On top of the same wall, the coping has separated from the pool deck, with failed sealant.

Main Pool – Separation of Coping from Pool Deck with Failed Sealant

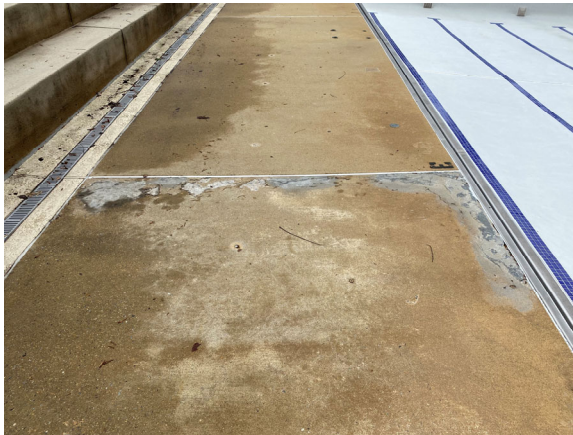
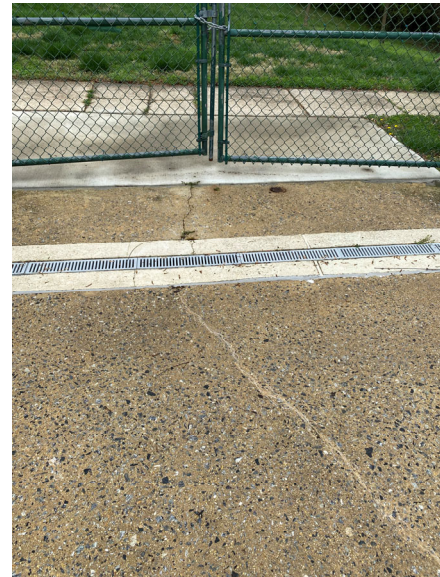
The pool decks immediately adjacent to the Pools are showing signs of aging with some limited cracking and areas where the concrete is spalling (surface breaking off) and previous patching is failing. In some areas, the surface of the concrete is eroded. It should be expected that these conditions will gradually worsen as the slabs age.

Pool Deck – Cracking, Failing Patches, and Surface Erosion

The cracking observed is consistent with thermal movement and/or shrinkage of the concrete from the original curing process. In some cases, cracks radiate from penetrations and other changes in geometry, which are natural places for cracking to occur.

Spalling is the typical end state of the deterioration of reinforced concrete, where the reinforcing steel within the slab corrodes, leading to separation of the concrete surface (delamination) from the underlying concrete, eventually resulting in spalling.

Chlorinated water tends to exacerbate the deterioration of concrete. In addition to causing corrosion of the reinforcing steel, the chlorine eats away at the cement component within the concrete. This is apparent in the areas where the surface is eroded. Similar deterioration can be, and likely is, happening within the concrete, where cracking or spalling serves as a pathway for water to enter deeper into the concrete.

Route and seal cracks to prevent water penetration.

Remove spalled areas and failed previous patches down to sound concrete. Patch with a high-quality patch material suitable for this application, following manufacturer's recommendations for surface preparation, application, and curing.

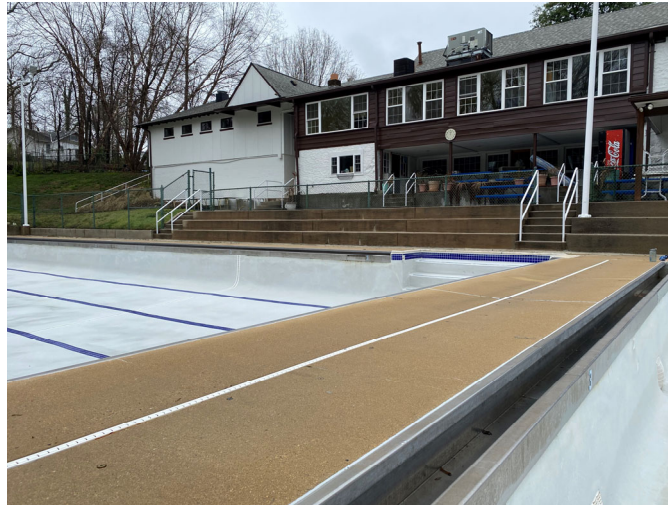
The Pool Deck slab at the bulkhead which subdivides the Main Pool sounds very hollow.

Pool Deck -Bulkhead Slab

Based on the 1988 Pool Renovation drawings, this slab was designed as slab-on-grade, intended to be permanently supported by gravel from below, and not designed to span between pool walls. Presumably the gravel fill beneath the slab has consolidated (settled) away from the bottom of the slab. This separation causes the slab to sound hollow.

Unless the slab was constructed differently from what the drawings show, this is a potential safety concern. While the amount of consolidation beneath the slab is likely to be small, the slab could crack and drop. The slot drain that runs down the middle of the slab is at the point of maximum flexural stress, which does not improve the situation.

The bulkhead slab-on-grade should be repaired as soon as possible. There are two approaches that can be taken:

1. Remove the existing slab-on-grade.
2. Consolidate the gravel fill beneath the slab.
3. Provide a new slab-on-grade. Design the slab-on-grade with sufficient thickness and reinforcing steel so that the slab can safely span wall to wall, if future consolidation of the underlying gravel occurs.

An alternative to removal and replacement is to core holes in the slab and pump grout beneath the slab to fill the voids. Some limitations of this alternative are 1) care must be taken to avoid lifting the slab (which can cause cracking) and 2) the potential for future consolidation of the underlying gravel remains possible.

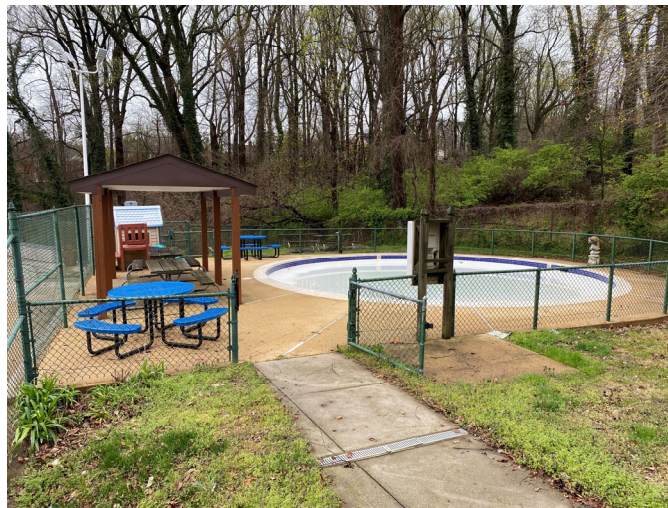
The Pool Deck surrounding the Wading Pool sounds very hollow around the perimeter of the pool and adjacent to the retaining wall between the Main Pool and the Wading Pool, below the canopy structure.

Pool Deck -Wading Pool

The hollow sound adjacent to the Wading Pool is likely due to settlement of soil adjacent to the pool wall, beneath the slab. The hollow sound adjacent to the retaining wall is likely due to settlement of soils behind the wall, beneath the slab.

This is a potential safety concern. While the amount of consolidation beneath the slab is likely to be small, the slab could crack and drop.

The slab-on-grade surrounding the Wading Pool should be repaired as soon as possible. Given the age, condition, and relatively small size of the slab, it is recommended that the existing slab be removed and replaced with a new soil-supported slab-on-grade.

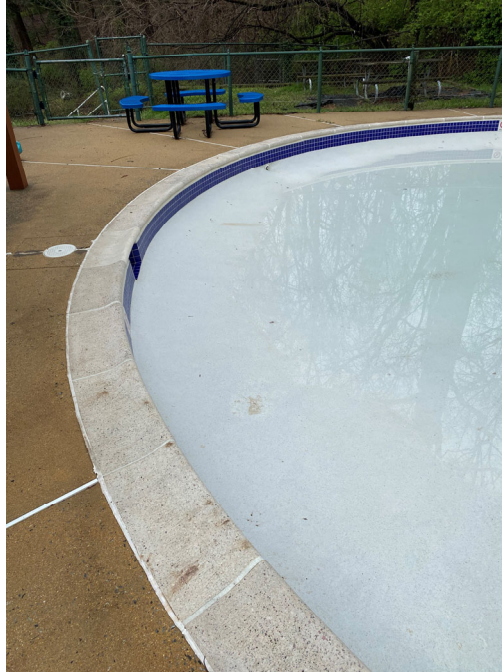
Approximately 25% of the coping sounded hollow.

Pool Deck -Coping at Wading Pool

The hollow sound indicates that the coping segments are debonded from the underlying pool wall.

Remove and re-set all loose coping segments. All coping stones must be fully bedded below without gaps, except at expansion joint locations.
